APPENDIX K

CUMULATIVE STATISTICS ON
EXCEEDANCES, ENVIRONMENTAL
COMPLAINT, ENVIRONMENTAL SUMMON
AND PROSECUTION LOG

**Submarine Cable for the Development of the Integrated Waste Management Facilities
(IWMF) Phase 1***Further Environmental Permit (FEP-02/429/2012/B)***Environmental Complaint - Complaint Interim Report***Our ref: 0691230_IR001_muddy water (for16Dec2023)_R1.docx*

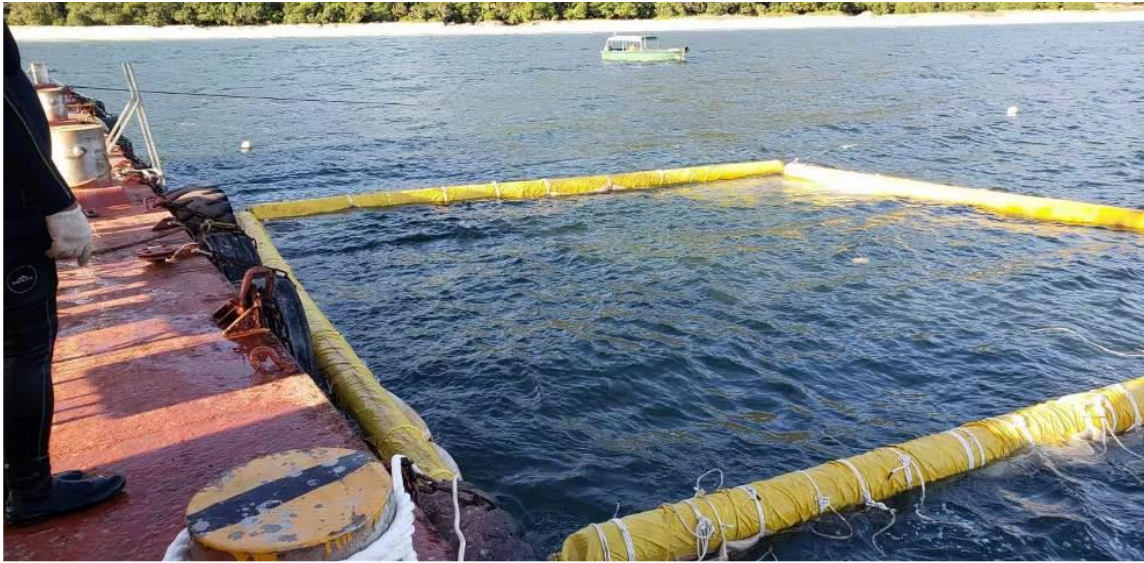
Photo 1 Hand jetting within cage type silt curtain as mitigation measure taken on 8 Dec 2023

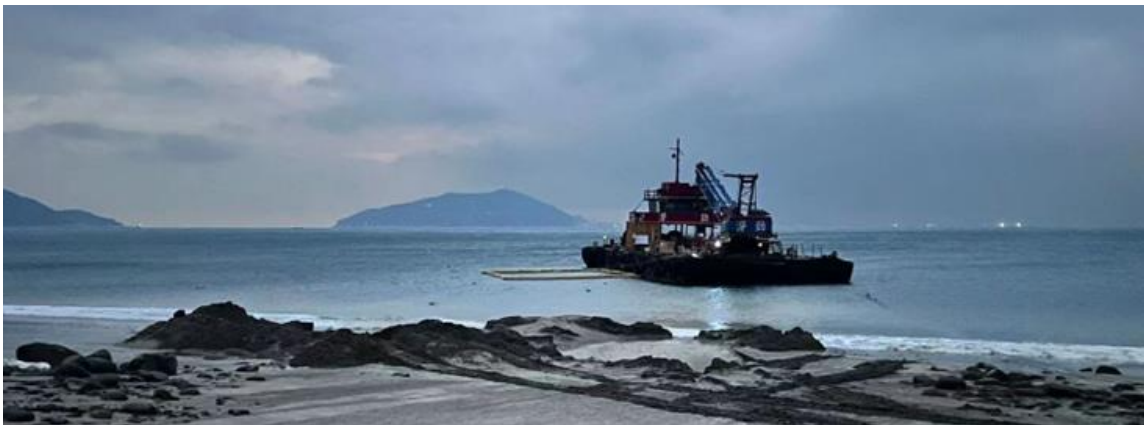
Photo 2 Photo of silt curtain setup taken on 16 Dec 2023

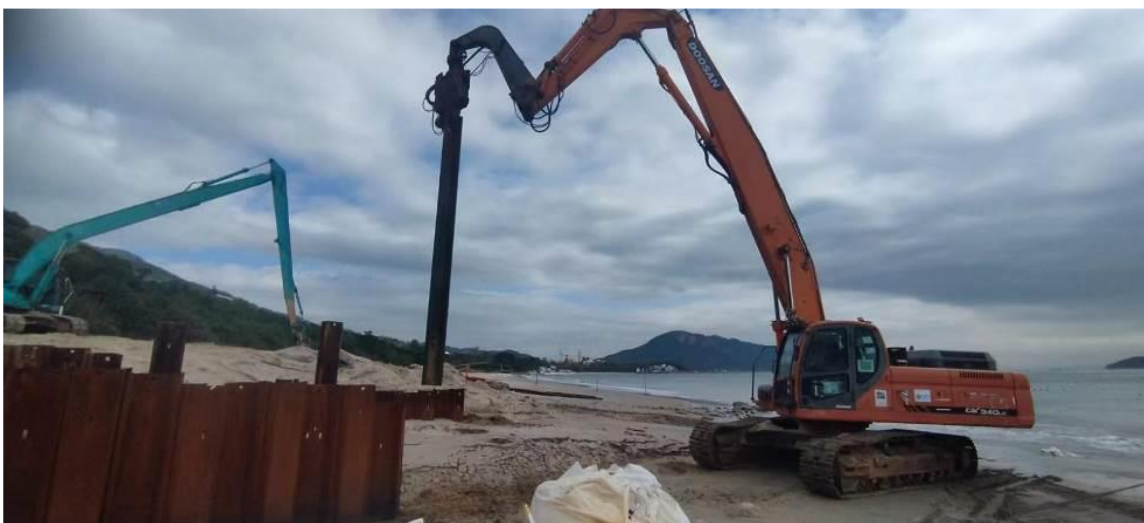
Date of Complaint	16 Dec 2023
Date of EPD Notification to IEC	18 Dec 2023
Compliant Reference	Cable IWMF_IR001
Description of the Complaint	A complaint referral was received from EPD on 18 Dec 2023 concerning muddy water discharging into the beach from the site of IWMF cable laying project at Cheung Sha. They reported that no barriers/nets were used to prevent the discharge. The incident time was reported to be at 16 Dec 2023 (Sat).
Actions Taken / To Be Taken	<ul style="list-style-type: none">• IEC and ET notified the client and contractor immediately regarding the received complaint.• Information on works carried out and mitigation measures in place were provided by the client and contractor on 20 Dec 2023.• ET to submit a Complaint Interim Report to EPD within 7 working days.• No immediate action required.• A site inspection (weekly site audit) was carried out on 19 Dec 2023.
Investigation Findings	<ul style="list-style-type: none">• Marine hand jetting works were carried out in the morning of 16 Dec 2023 but ceased before noon because of adverse weather condition. All hand jetting works by diver were carried out within a cage type silt curtain (see Photo 1 and Photo 2 in Annex A).• Sheet pile removal works by excavators were carried out at Cheung Sha Upper Beach on 16 Dec 2023. There was no muddy water generated or discharged due to the works (see Photo 3 taken on 16 Dec 2023 in Annex A).

Photo 3 Photo of sheet pile removal works taken on 16 Dec 2023

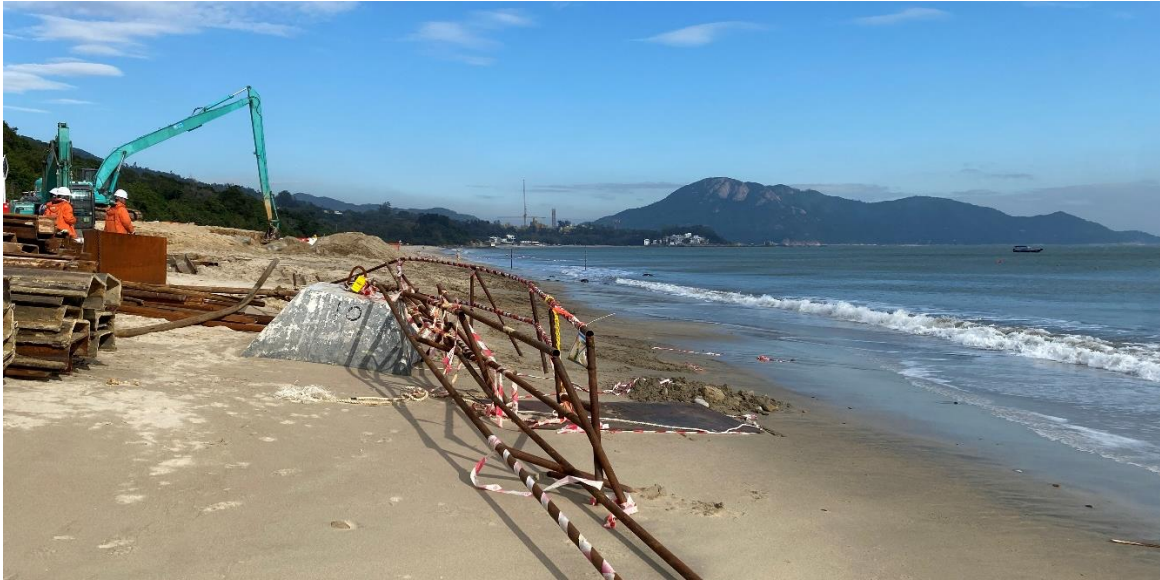
Photo 4

Photo taken on-site on 19 Dec 2023
