APPENDIX K

CUMULATIVE STATISTICS ON
EXCEEDANCES, ENVIRONMENTAL
COMPLAINT, ENVIRONMENTAL SUMMON
AND PROSECUTION LOG

**Submarine Cable for the Development of the Integrated Waste Management Facilities
(IWMF) Phase 1***Further Environmental Permit (FEP-02/429/2012/B)***Environmental Complaint - Complaint Interim Report***Our ref: 0691230_IR001_muddy water (for16Dec2023)_R1.docx*

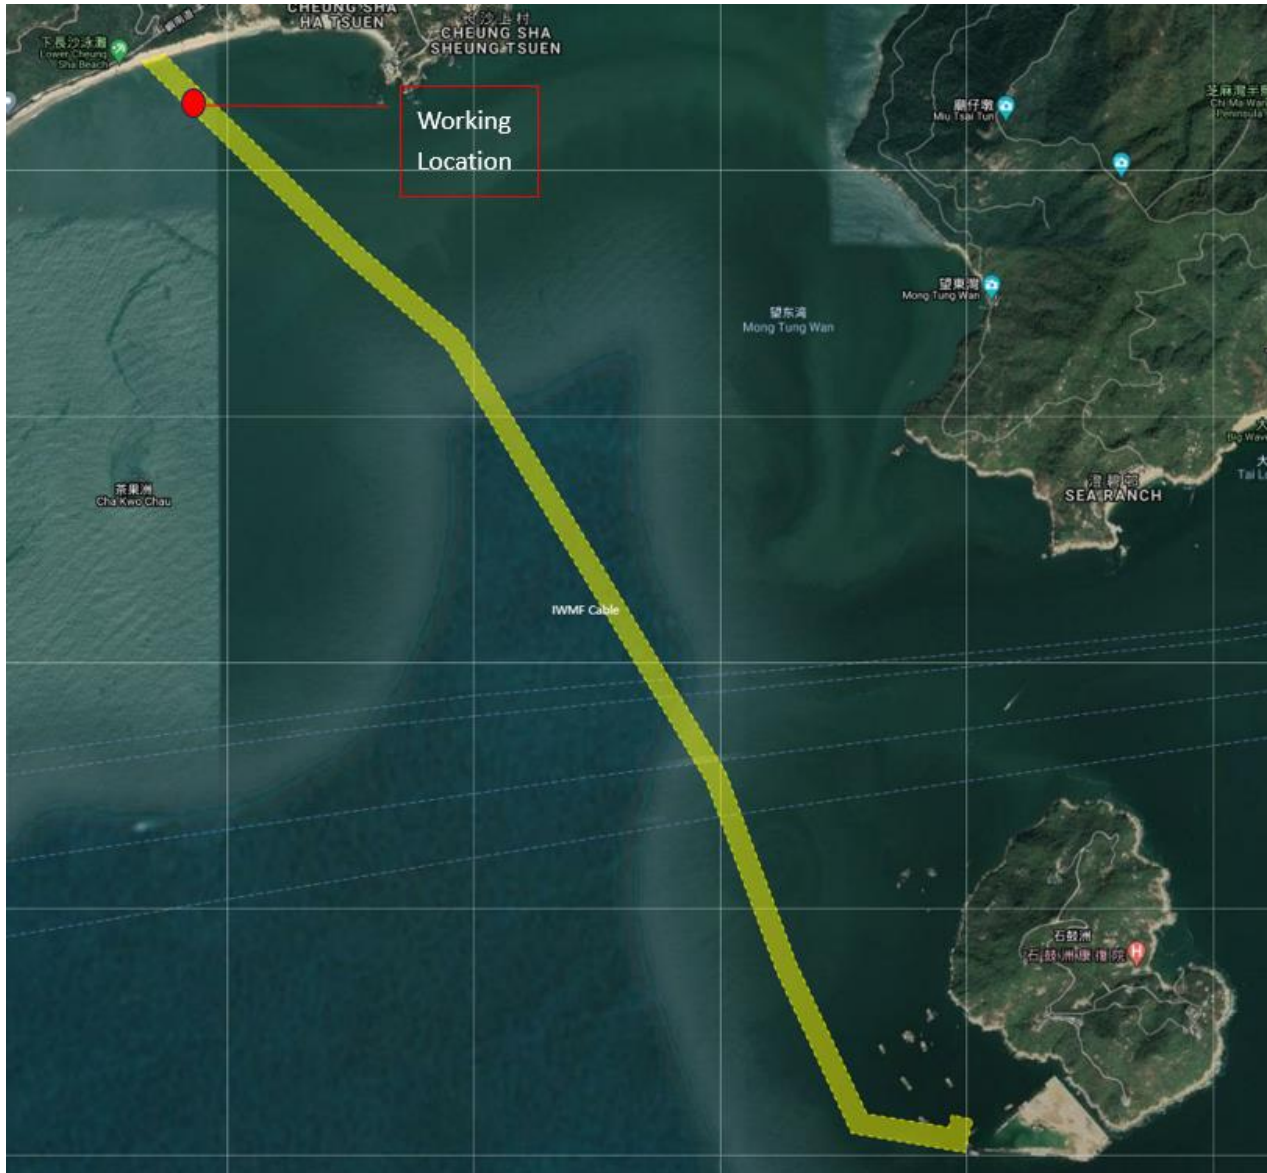
WORK AREA ON 16 DEC 2023

Possible reason(s) for the Complaint	There was no mud and soil present at the work site and there was no muddy water generated or discharged due to the works. Given that it was quite windy on 16 Dec 2023, sand on the beach might be washed out to the sea by wave and tidal.
Follow-up Site Visit	A site inspection (weekly site audit) was carried out on 19 Dec 2023. No activities that would generate muddy water were observed. Sheet pile removal works were almost completed and pending for transportation away. Site reinstatement and clean up works were in progress (please see Photo 4 in Annex A).
Conclusion and Recommendations	<p>With reference to the information provided by the client and contractor, and observation of our site inspection, the mitigation measures provided to the concerned works are in place and deployed properly. No particular muddy water dispersion was observed during the construction works on 16 December 2023 and the follow-up inspection on 19 December 2023. Given the above, it is considered that there is no non-compliance due to the work activities being carried out on-site, and follow-up action, remedial action and additional monitoring are not required.</p> <p>The contractor is required to implement relevant mitigation measures and weekly site inspection will continue to be carried out to audit the implementation of the mitigation measures till completion of all project works in accordance with the EM&A requirements.</p>
